The gas grill on the below appliances are designed to be used with the grill door fully open. It has come to our attention that IF THE GRILL DOOR IS CLOSED WITH THE GRILL BURNER LIT, DANGEROUS LEVELS OF CARBON MONOXIDE CAN BE PRODUCED.

Belling G755 White(50531081) & Belling Country Chef 100G
Anthracite(50531082) Anthracite(444445946) &
Belling GT755 White(444449050) Silver(444445945)

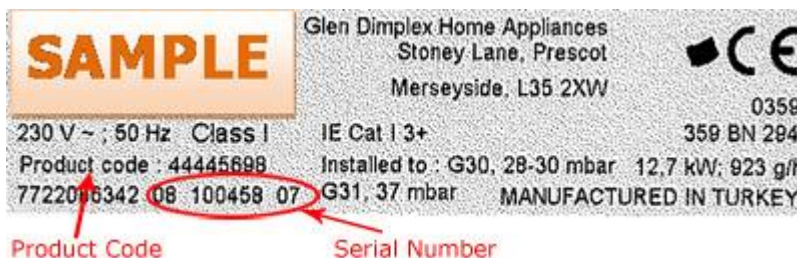
The serial number can be found on the data plate at the bottom front edge of the appliance.
